Moskva Hit Location

Moskva Missile Damage

Moskva Damage Summary

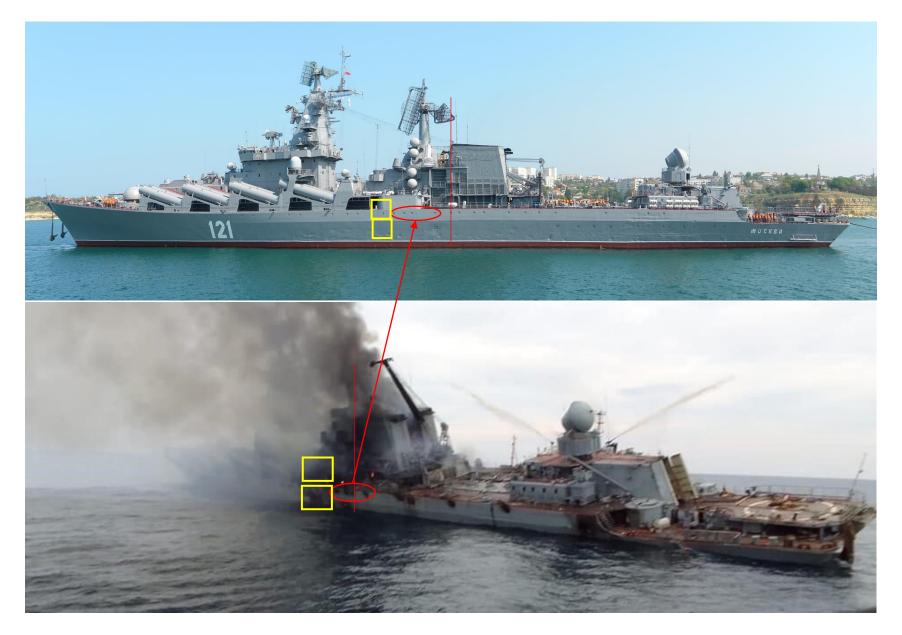
There is reasonable evidence to say two Neptune ASCMs hit Moskva, impacting the hull close to each other.

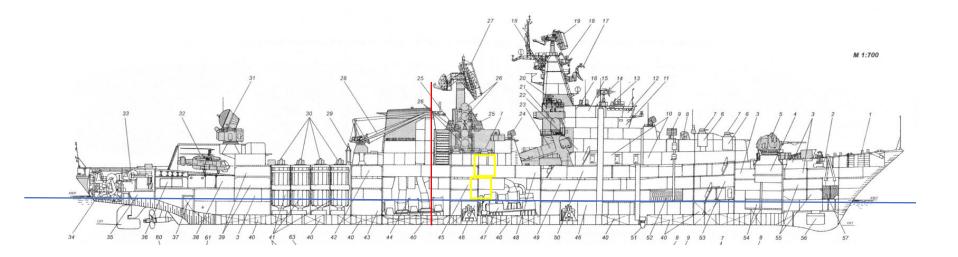
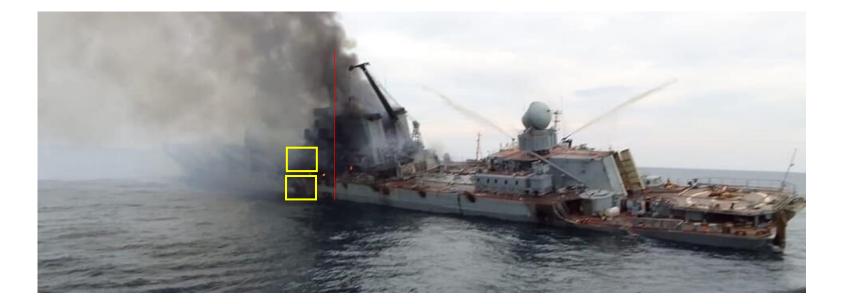
Moskva Hit Location

The missile impact just at the waterline could have exploded in space #45 or #47. Either way both locations would have suffered considerable damage and would have had major fire from the remaining fuel in the missile. This assumes a max missile range of 151 nmi (280 km) with only 65 nmi of fuel consumed. Adjoining compartments could have experienced serious damage as well. If the missile exploded in space #45, then both engine rooms would have likely been seriously damaged and on fire.

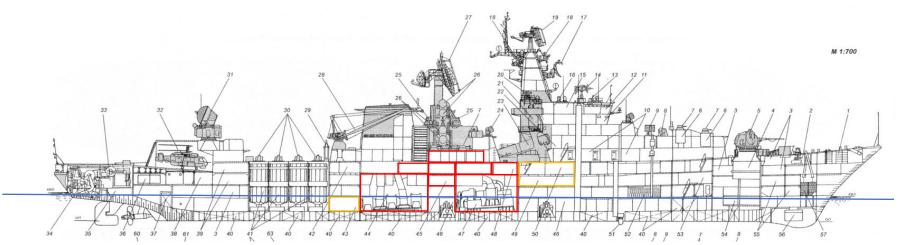
Space #45 is also very important as it is the room from which all types of energy are distributed on the ship and control is carried out in the fight for the survivability of its combat and technical means. PEJ is equipped with means of information about the operation of mechanisms, diagrams, electronic computing devices, means of communication and remote control of systems fire extinguishing, dehumidification of premises (take this as dewatering of flooded compartments), ship straightening (list control), etc. (Russian Naval Dictionary).

- 43 энерго отсек
- 44 кормовое МО (форсажные ГТД)
- 45 пост энергетики и живучести ПЭЖ
- 47 носовая МО (маршевые ГТД)
- 48 носовая электростанция
- 49 боевой информационный пост БИП
- 50 главный командный пункт ГКП

energy compartment stern MO (afterburner gas turbine engines) post of energy and survivability PEJ bow MO (marching gas turbine engines) bow power plant combat information post BIP main command post GKP

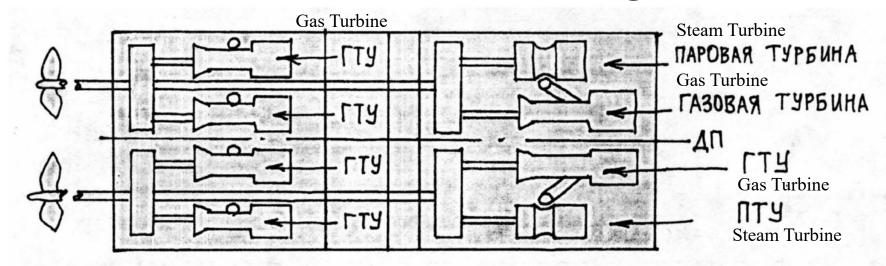
Moskva Missile Damage

47 – носовая МО (маршевые ГТД) bow MO (marching gas turbine engines) This is the forward engine room with two M-70 cruise gas turbines (10,000 hp each) and the steam turbines (2,500 hp each) that use waste heat from the gas turbines to produce steam in a heat recovery circuit (TUK).

44 - кормовое MO (форсажные ГТД) stern MO (afterburner gas turbine engines) This is the after engine room with four M-8KF boost gas turbines (22,500 hp each). Total maximum propulsion power is 115,000 hp.

These are potentially two of the three compartments that generate electrical power. Each compartment has two gas turbine generators, one with a power rating of 1,500 kW and another with a power rating of 1,250 kW. Total electrical power generation capacity is 8,250 kW. There is also a diesel-generator to provide power for emergency lighting. The electric plant is controlled from, the main command post (#50), the post of energy and survivability (#45), and an unidentified emergency control room.

A missile hit in the forward engine room would very likely cause significant damage to the cruise gas turbines and steam turbines and could potentially distort the main shaft sufficiently to cause damage to the reduction gears of the boost turbines.

Heavy damage in the post of energy and survivability (#45) compartment could cause a loss of all electrical power, as well as potentially disabling the ship's automated damage control capability.

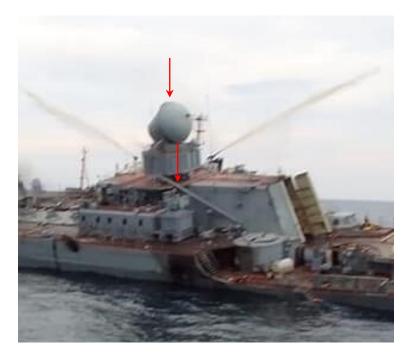
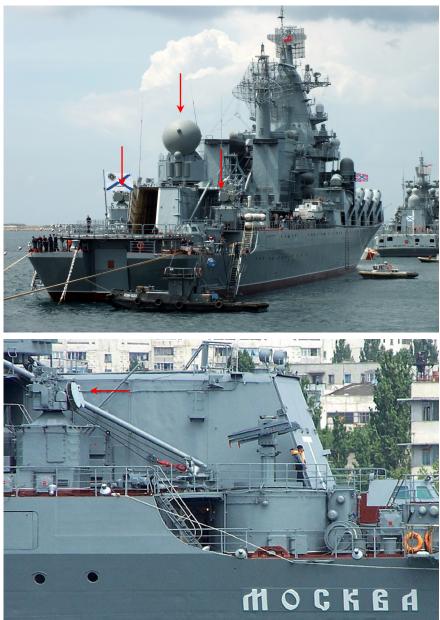
Moskva SAM Directors

There is no indication *Moskva*'s air defense missile systems were ready for action as both the 3R41 Volna [Top Dome] and the 4R-33A/MPZ-301 Baza director/scanning radar combination [Pop Group] are trained aft in their typical stow position.

- 7) All three SAM directors (3R41 Volna [Top Dome] and the two 4R-33/MPZ-301 director/scanning radar combination [Pop Group] for the OSA-MA [SA-N-4]) were facing aft in their normal stow position. This indicates the air defense systems were either not manned or in stand by. BTW, the Pop Group has a dedicated scanning antenna on top, this is the MPZ-301 Baza system, that conducts a dedicated low altitude air search for the Osa-MA to improve its reaction time.
